NARROMINE RIVERSIDE PRECINCT

Narromine Shire Council
Culling St, Narromine NSW
Wiradjuri Country

Narromine Riverside Precinct
Culling St, Narromine NSW
Wiradjuri Country

CLIENT Narromine Shire Council
DATE 27.07.20
PROJECT J533

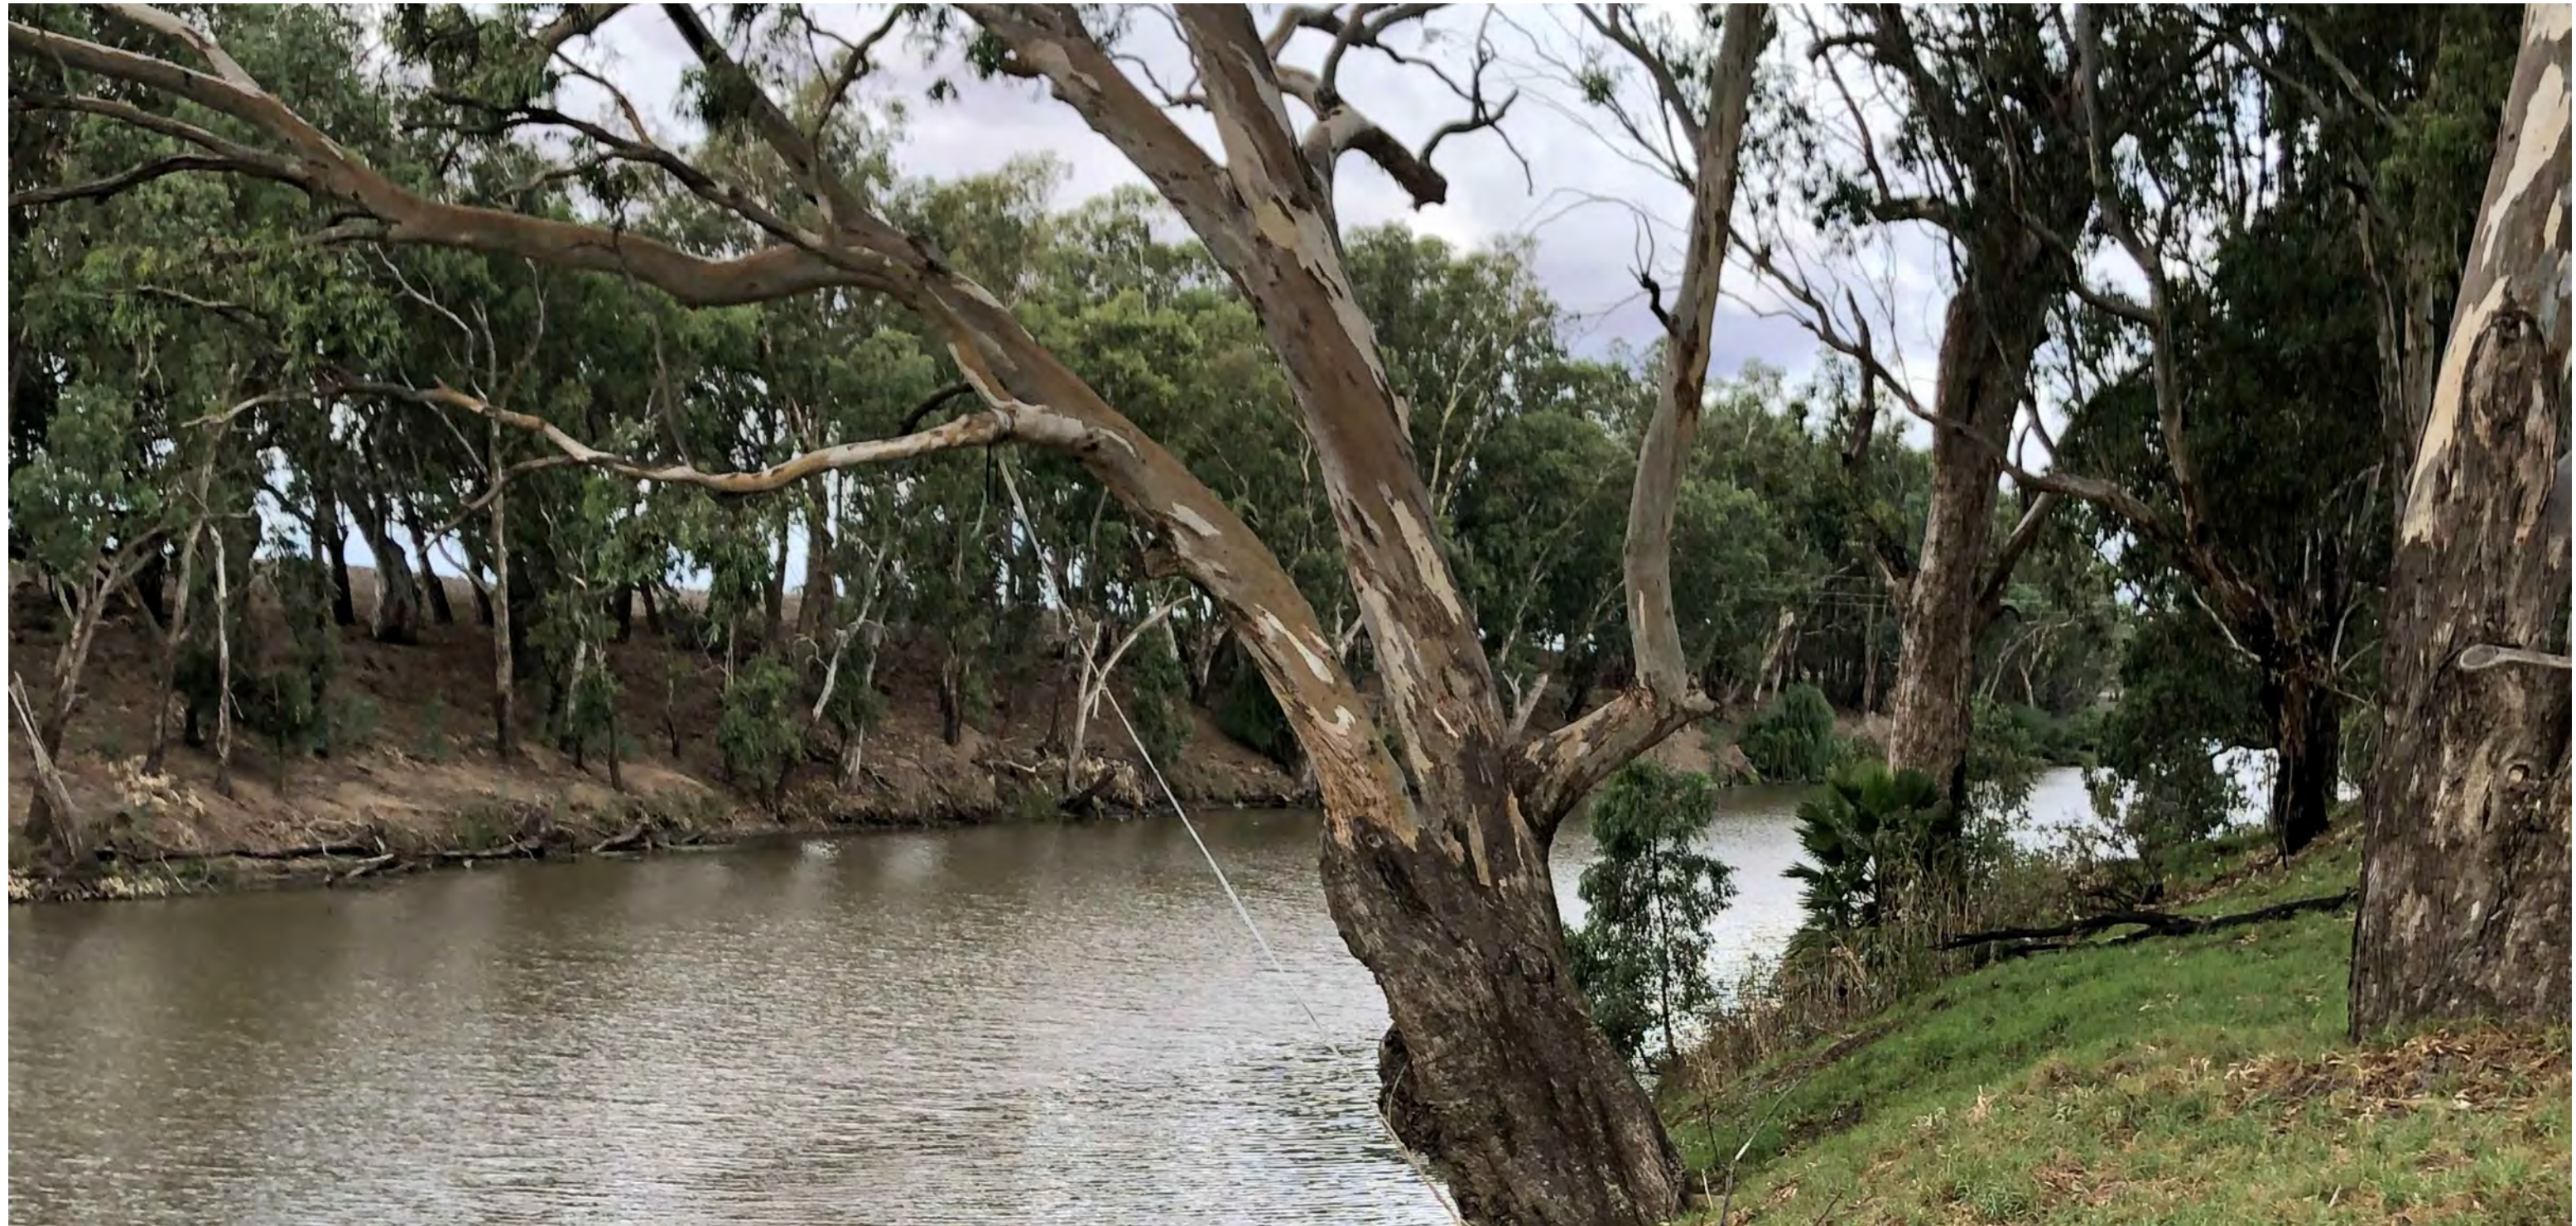
- Existing trees**
Trees located with aerial photo and survey
All trees retained wherever possible. Some trees will be removed as part of the upgrading of the levee bank.

- Proposed trees**
Riparian trees: Red River Gum (*Eucalyptus camaldulensis*) Silver Wattle (*Acacia dealbata*) River She Oak (*Casuarina cunninghamiana*)
Tree along levee bank and into parkland: Chinese Elm (*Ulmus parvifolia*)
Manna Ash (*Fraxinus ornus*) Blackwood (*Acacia melanoxylon*) Urbanite Ash (*Fraxinus pennsylvanica* Urbdel)

- Shared paths.**
1.8m wide stabilised decomposed granite.
- Concrete walls**
as terrace seating areas (450mm height)
- Proposed contour of levee raised**
750mm and earth shaped to provide mowable grade (1:4) and terrace seating for viewing.

- Gravel carpark zones**
Parking provision includes line marking and wheelstop
Spaces shown are 2.4 x 5.4 and adaptable carparking at 3.8 x 5.4m
- Irrigated grass areas**
Includes playing fields, cricket oval, play ground area and small grass areas at important areas for community use.

- Planting areas**
Riparian areas: Bursaria (*Bursaria spinosa*) Mat Rush (*Lomandra longifolia*) River Tea tree (*Leptospermum myrtifolium*)
River Bottlebrush (*Callistemon sieberi*) Weeping Boree (*Acacia vestita*) River Cooba (*Acacia stenophylla*)

- Entrance plantings (low water use)**
Ground cover saltbush (*Rhagodia spinescens*) Emu Bush (*Eremophila kalbarri*) Carpet (*Lomandra tanika*)

- Elements**
- Seating and Congregation areas
- Picnic tables
- Bins/ Bike racks/ Bubbler/ water refill station
- Relocated exercise equipment
- Play equipment
- Relocated farm equipment

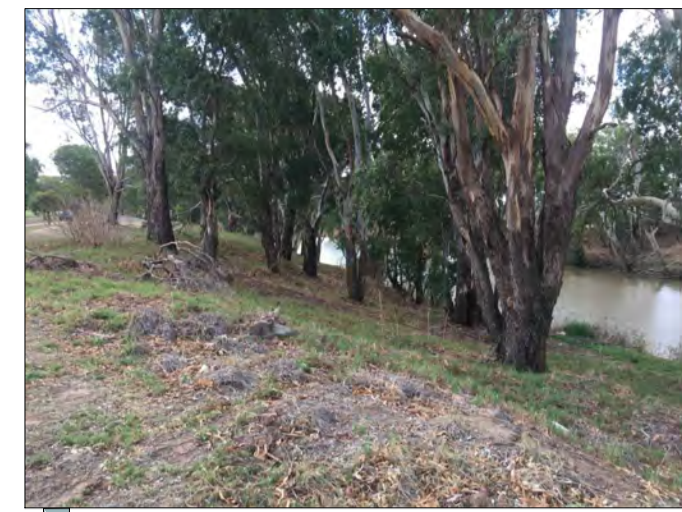
Riverbank

- Beautiful River Red Gums including ancient trees along the river. Couch and Kikuyu. Difficult steep slope to mow or slash
- Bursaria, Lomandra, Silver Wattle and Phragmites along river. One Casuarina
- Opposite side is eroded
- Steep embankments becoming less so to the eastern end
- Weeds include Tobacco plants and Green Cestrum and Silver Nightshade
- Fishing from banks is difficult due to steep nature
- There is an existing Rope ladder/ tree ladder
- Shopping trolleys/ bike/ rubbish down along river

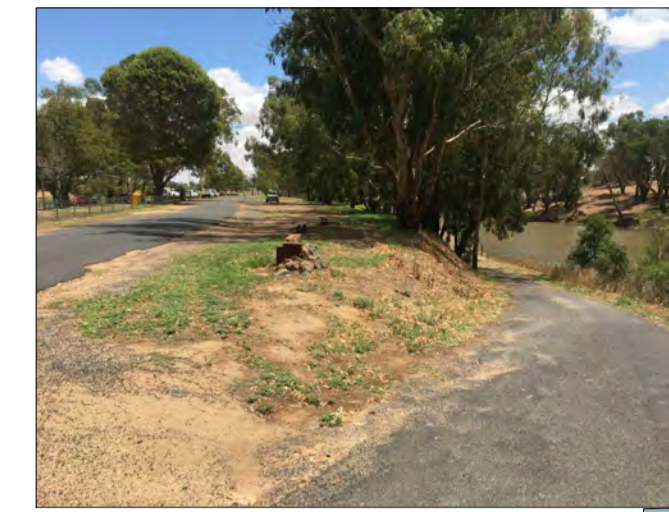
Boat Ramp

- Boat ramp is for fishing only (not ski boats)
- 2 way traffic problematic
- Kayaks can take off from the boat ramp but this needs improvement

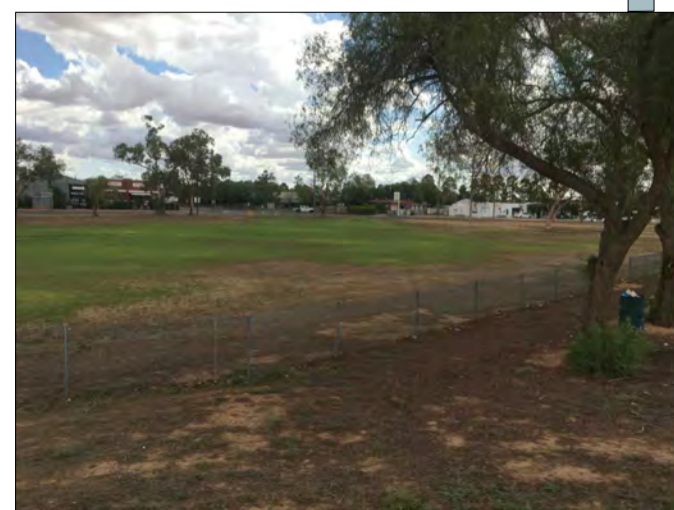
Current Cricket Oval uses

- Junior cricket can only use this concrete pitch however the ground is not big enough to play comps on so are played in Dubbo.
- Seniors cricket is elsewhere
- St Augustines use the cricket area as an active play zone for cricket and touch footy.
- It's an important visual landscape as part of the entrance and exit to town
- Space is lacking in character

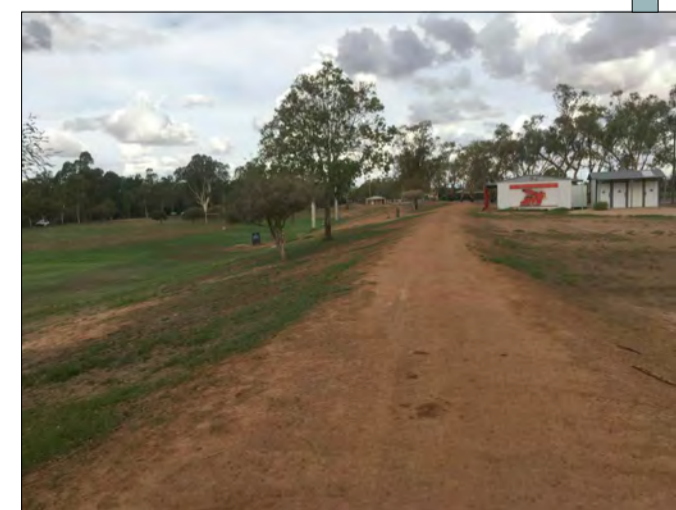
Sporting fields

- Clubhouse and toilets are located above the floodline
- Sport-Junior Rugby League Home ground and Rugby union training
- School Cross Country-great as there are no road crossings on the site.
- PSSA Rugby and League comp Sport development days .
- More bus parking needed
- Vandalism/ driving onto the fields is a problem
- Management of the fields is difficult as drainage is impeded.

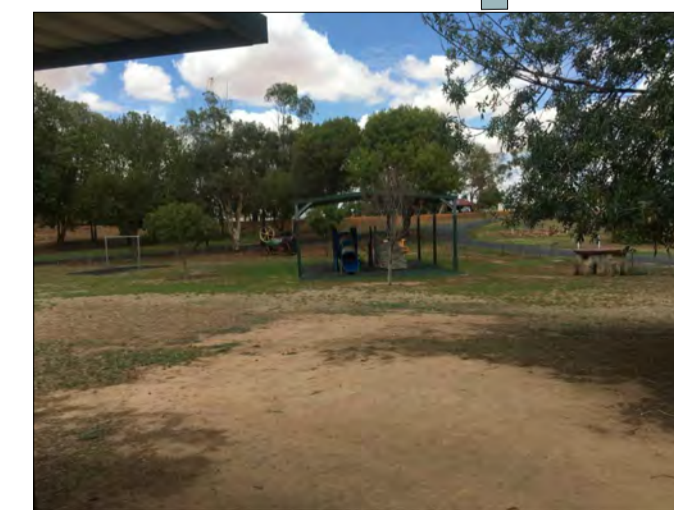
Western section

- Was a TSR and there was a bridge at this end (electricity running over)
- Fenced dog area has not been well received. No equipment or shade.
- Unused, passive area of the precinct
